Analysis of fire spread Kloek Pallets, Kampen, The Netherlands

Report no.	2014-Efectis-R0105.119
Sponsor	Kingspan Insulation Lingewei 8 4004 LL TIEL
Author(s)	M.P. de Feijter B.Be. A.D. Lemaire M.Sc.
Project number	2014105/119
Date of issue	June 2014
Number of pages	17

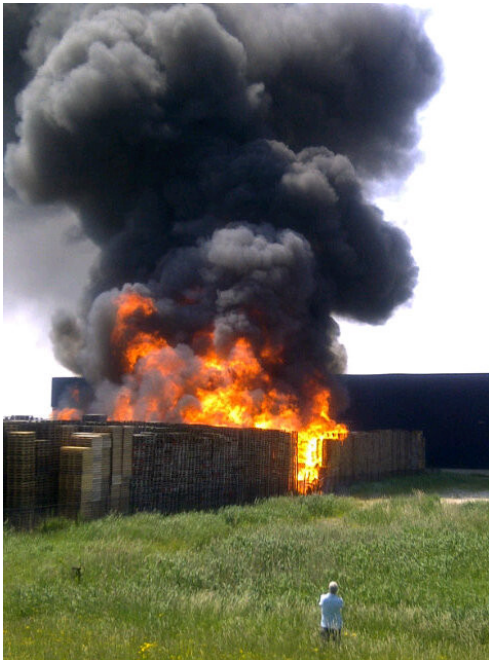
The fire department was alarmed at 13:15:48h. After 1 minute the alarm was raised to “middle”, 8 minutes later the alarm was raised to “large” and 14 minutes later to “very large”. One of the first pictures was posted on the internet at 13:26h (figure 4). The position of this first fire in the pallet stack is represented by the red dot in figure 2. The picture is taken from the side of the “Haatlandhaven”.

Figure 4 One of the first pictures posted on the internet¹ at 13:26h

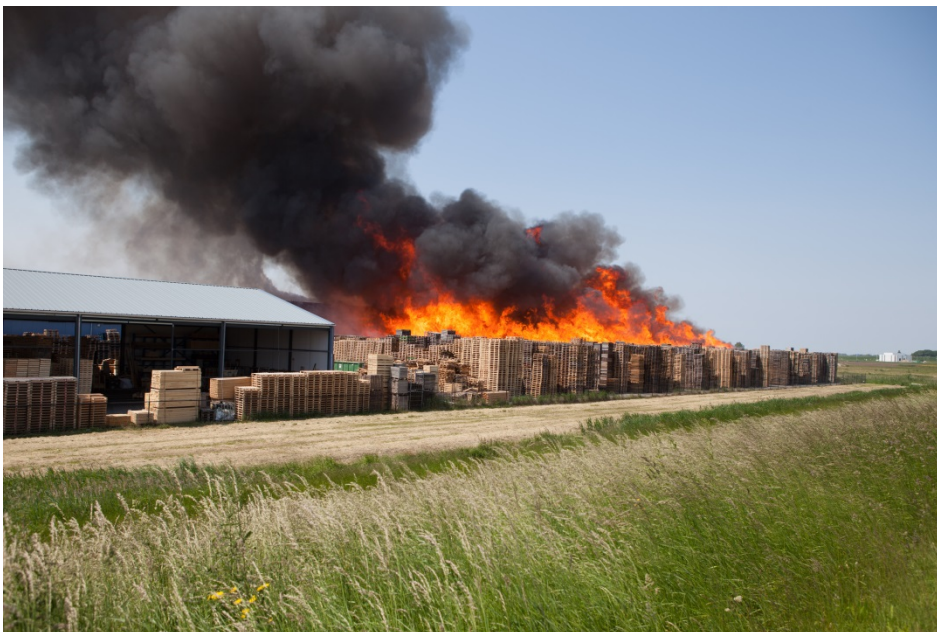
The two photo series that were obtained from two “fire photographers” start around 13:38h. At this time the fire has reached the edge of the pallet stack at the side of the Asia building.

Figure 5 Picture from the side of the “Haatlandhaven” at 13:38h (Source: Stefan Verkerk Fotografie en Webdesign)

In figure 5 and 6 the size of the fire seems to be doubled around 13:39h.

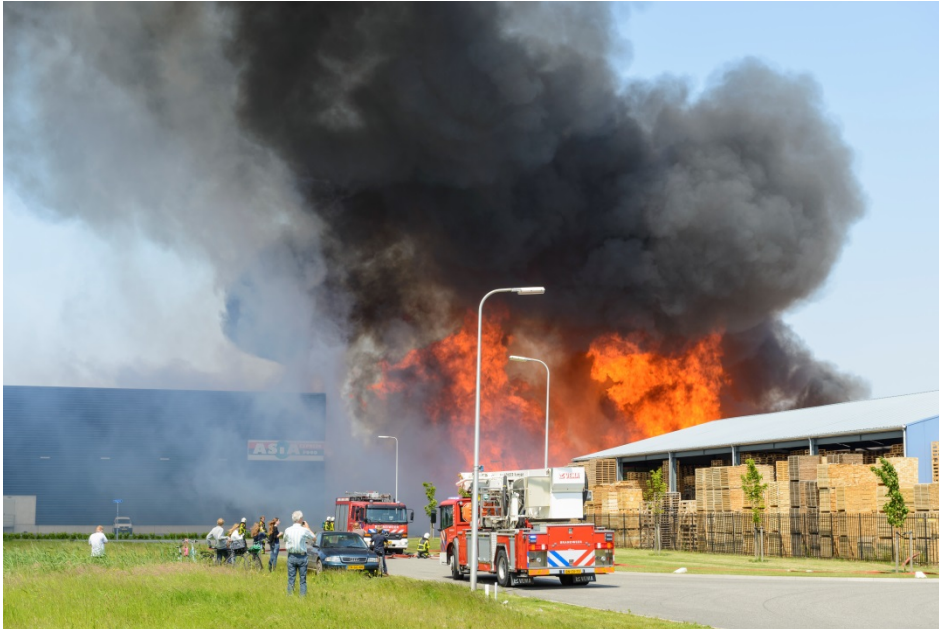
Figure 6 The size of the fire on the side of the Asia building at 13:39h (Source: Sjoerd van der Wal Fotografie)

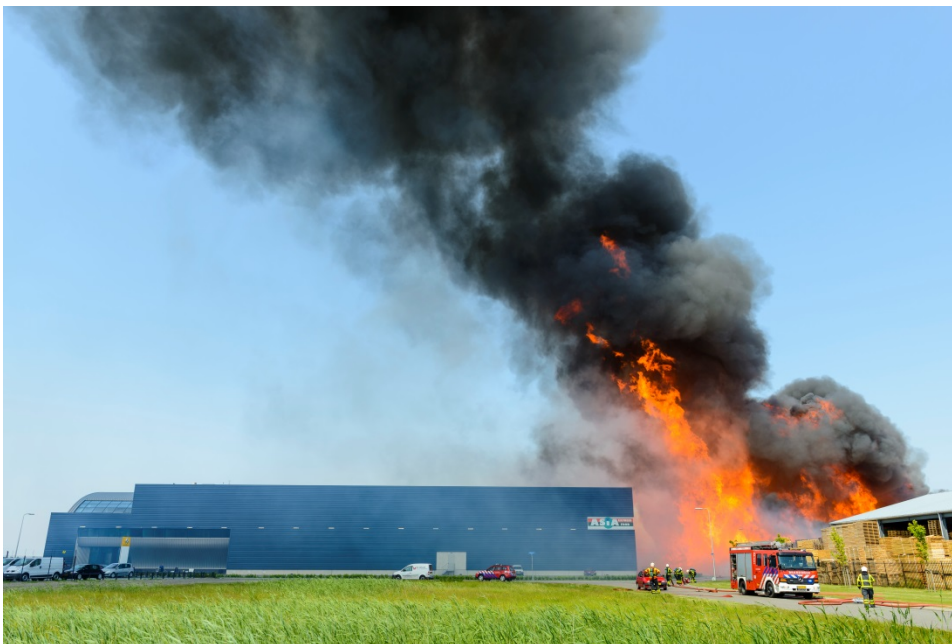
The height of the flame varies in time. Based on the photo's the average flame height is determined around 31 m (from the underside of the pallet stack). The pictures show that flames were as high as 45 m perpendicular to the ground. Flame length exceeded 50 m (Figure 7)

Figure 7 Flame length of up to 51m (Source: Sjoerd van der Wal Fotografie)

Due to the wind (3-4bft NNE) the flame was pushed over the Asia building. The average angle of the flame was approximately 18° of the normal (72° from the ground).

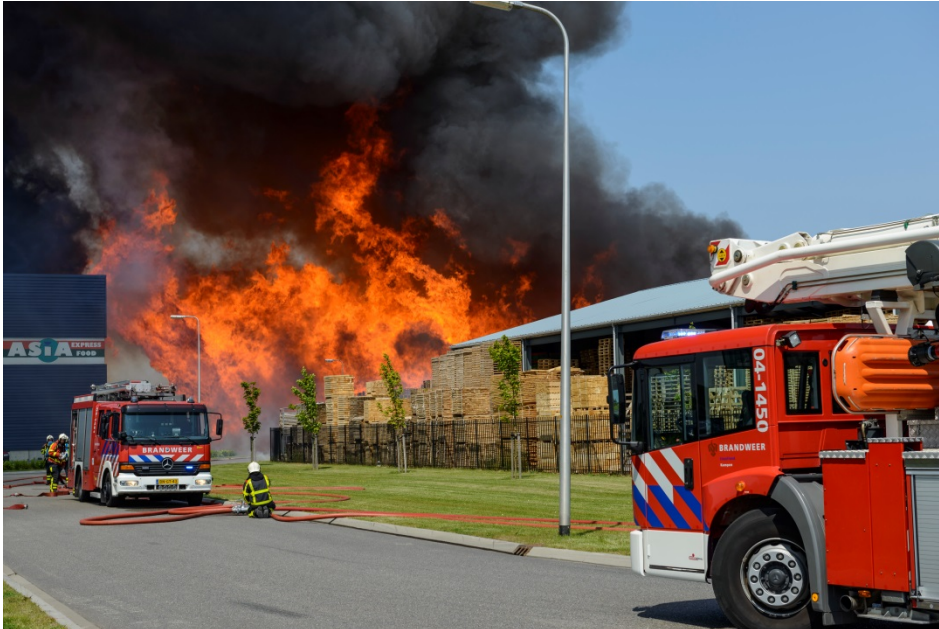
At 13:44h smoke is coming from the roof of the Asia building (figure 8) and at 13:48h flames are visible on the roof (figure 9).

Figure 8 At 13:44h smoke is coming from the roof of the Asia building (Source: Sjoerd van der Wal Fotografie)

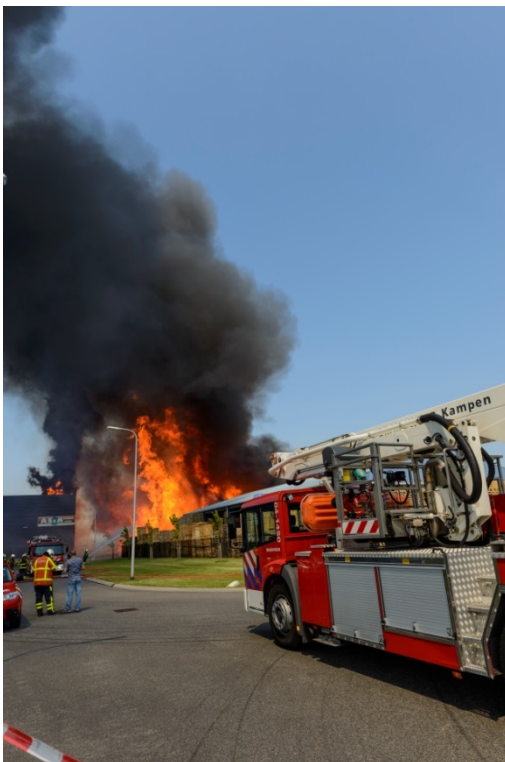
Figure 9 At 13:48h flames are visible on the roof of the Asia building (Source: Sjoerd van der Wal Fotografie)

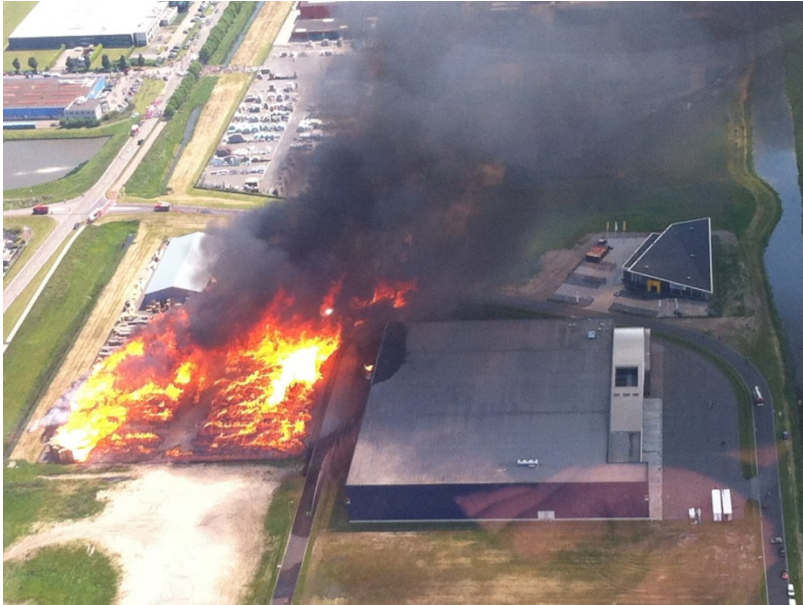
At 13:59h no more flames or smoke were visible on the roof of the Asia building. The fire department did not fight the fire on the roof because of the high heat flux². After the fire, the roof of the Asia building was damaged by the fire. The size of the fire and the impact on the roof are depicted in the aerial photo in figure 10.

Figure 10 Aerial photo of the fire and the damaged roof on the Asia building (Source: E. Driessen, zelfvliegen.nl)

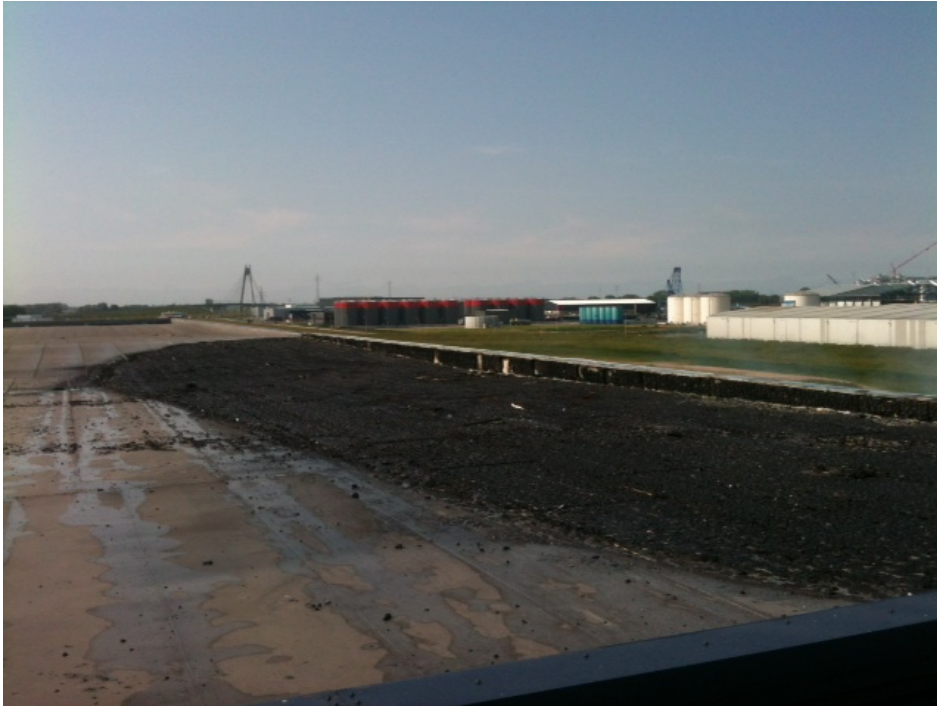
The damage on the roof is visible in figure 15. Figure 16 gives a close up impression of the damaged roof. The size of the damaged area is estimated based on the available photos and given in figure 2 (chapter 2).

Figure 15 Overview of the damage to the roof (Source: Kampen fire department)

The pictures show that the PVC roof covering was ignited. Therefore it has to be subjected to a heat flux of at least 15 kW/m². The insulation will ignite after the PVC roof covering has burned away. Compared to the calculations in chapter 4 the scenarios 2 and 3 are possible. Based on the surface temperature all 3 scenarios are possible.

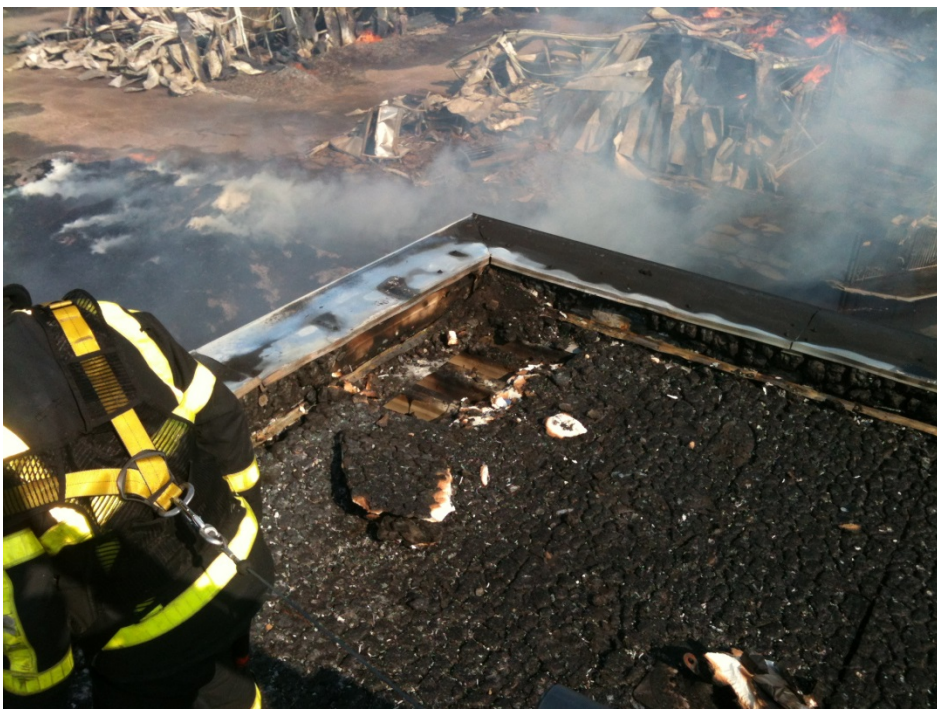
Figure 16 Damage to the roof of the Asia building (Source: Kampen fire department)

As stated the roof was made of a steel deck, a vapour barrier, a 65 mm insulation and a Rhenofol CV 1,2 mm (PVC-P) roof covering. PVC has a piloted ignition temperature between 320 - 440°C⁴, depending on the composition of the PVC. A flexible roof covering has a lower ignition temperature than a rigid PVC product. Ignition can be piloted by flying embers from the pallet fire.

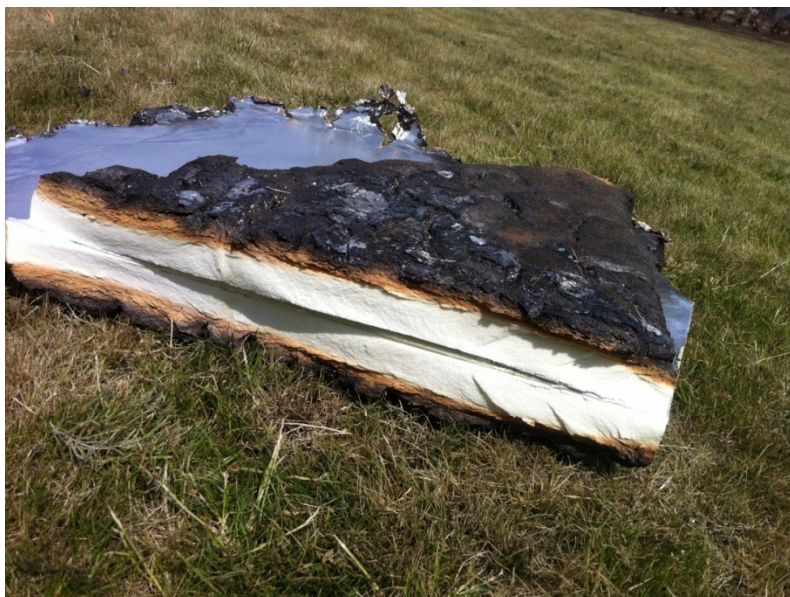
Based on the pictures it is clear that the roof was on fire during a period of 11 minutes. The fire on the roof self-extinguished without intervention of the fire department. Photos show that the insulation product was charred and discoloured for less than half of the thickness of the insulation sheet (figure 17).

Figure 17 Charring and discolouration of the insulation (Source: Kingspan Insulation)

Based on the photos it is safe to say that the fire died out when the heat flux level of the pallet fire diminished.
