Analysis of fire spread Kloek Pallets, Kampen, The Netherlands

Report no.	2014-Efectis-R0105.119
Sponsor	Kingspan Insulation Lingewei 8 4004 LL TIEL
Author(s)	M.P. de Feijter B.Be. A.D. Lemaire M.Sc.
Project number	2014105/119
Date of issue	June 2014
Number of pages	17

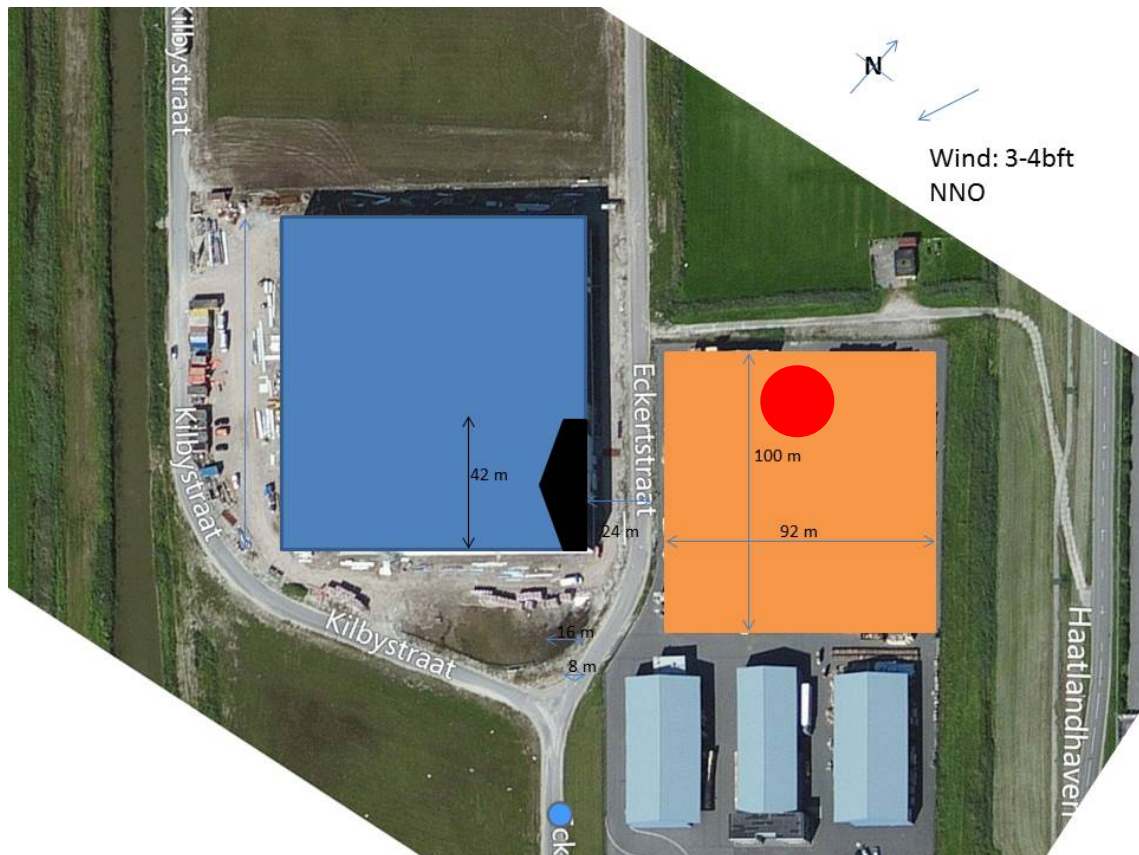
Figure 2 Situation with dimensions (Source: Bing maps)

On the premises of Kloek Pallets, pallets were stacked up to 5 m high (stacks of ± 35 Euro pallets) over a surface of 100 m wide and 92 m deep. The distance between the fence of the Kloek premises and the Asia building is 24 m.

The Asia building is (on the side of Kloek pallets) 110m wide and 14 m high. Figures 1 and 2 give an impression of the situation.

The damage on the roof is visible in figure 15. Figure 16 gives a close up impression of the damaged roof. The size of the damaged area is estimated based on the available photos and given in figure 2 (chapter 2).

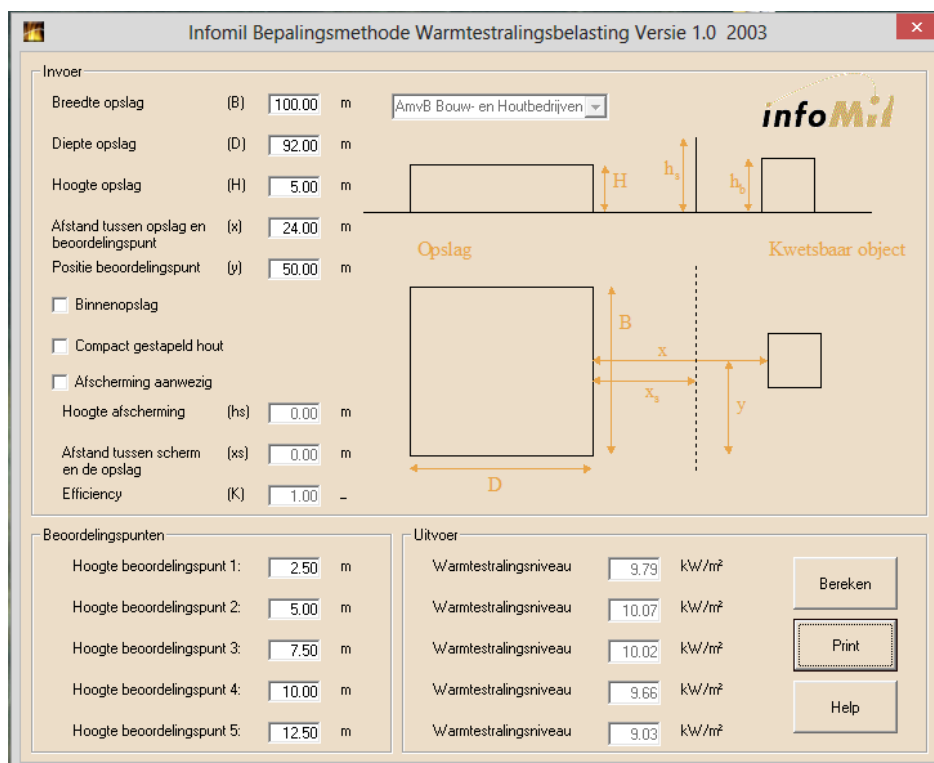
Figure 3 Heat flux calculation (Source: Infomil)

The fire safety rules for stacking pallets on a premises are given as a guideline in the VROM publication "Bepalingsmethode warmtestralingsbelasting opslag van hout". The prevention of fire spread from the stack to the adjacent premises is based on a maximum heat flux of 15 kW/m² on the face of the building. This heat flux can be calculated based on the dimensions of the pallet stack. An example is given in figure 3. This example uses the Infomil software that is used by the local government of the city of Kampen to check the required distance between the pallet stack and the building. Based on this calculation the fire should not be able to spread to the Asia building. However, based on calculations made by Efectis the

Infomil software seems to be limited to a maximum width of the stack of 37.5 m and cannot be used for a stack with a width of 100 m.

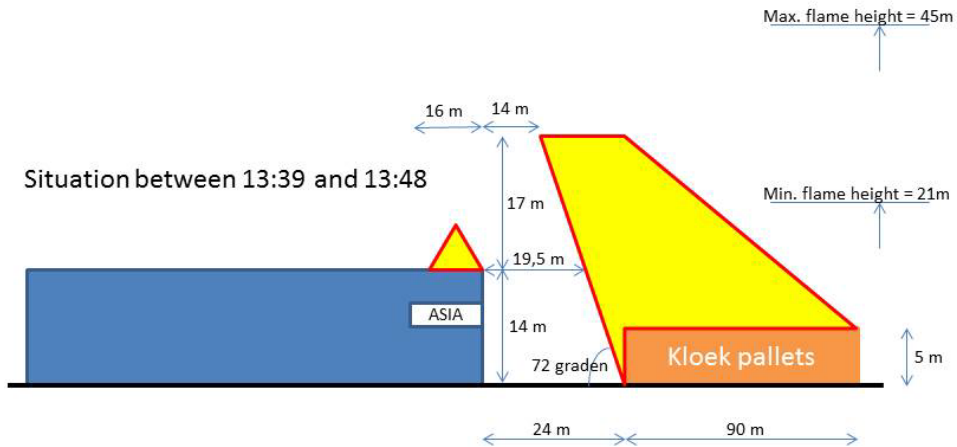
Figure 11 Fire size related to the size of the building

Based on the information given in chapter 3 the size of the fire and the average flame height were determined. The estimated size of the fire is depicted in figures 11 and 12.

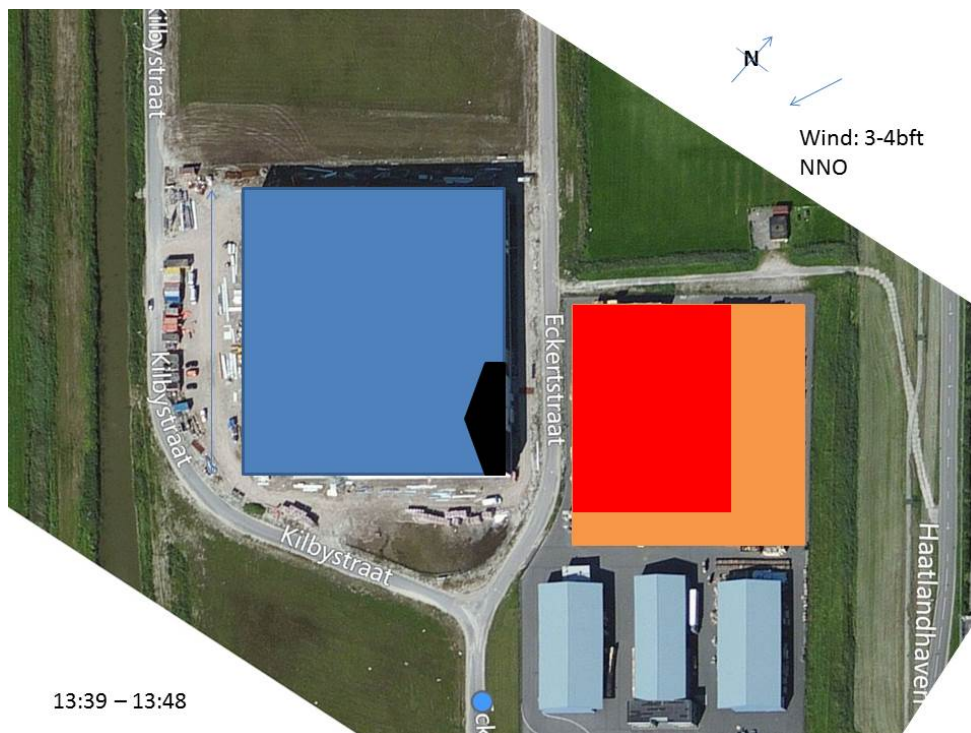
Figure 12 Estimated fire size at the time smoke was coming from the roof of the Asia building

To estimate the heat flux on the roof, calculations were made using "Shadow" software based on the pre-determined flame geometry. The radiant flame is modelled as a rectangular surface with a width of 96 m, tilted with an angle of 72° w.r.t to the ground. The horizontal distance of the base of the surface to the roof of the virtual Asia building is 24 m. (See figure 11). For calculation purposes the emission of the flame front is presumed to be uniform (radiant heat flux).

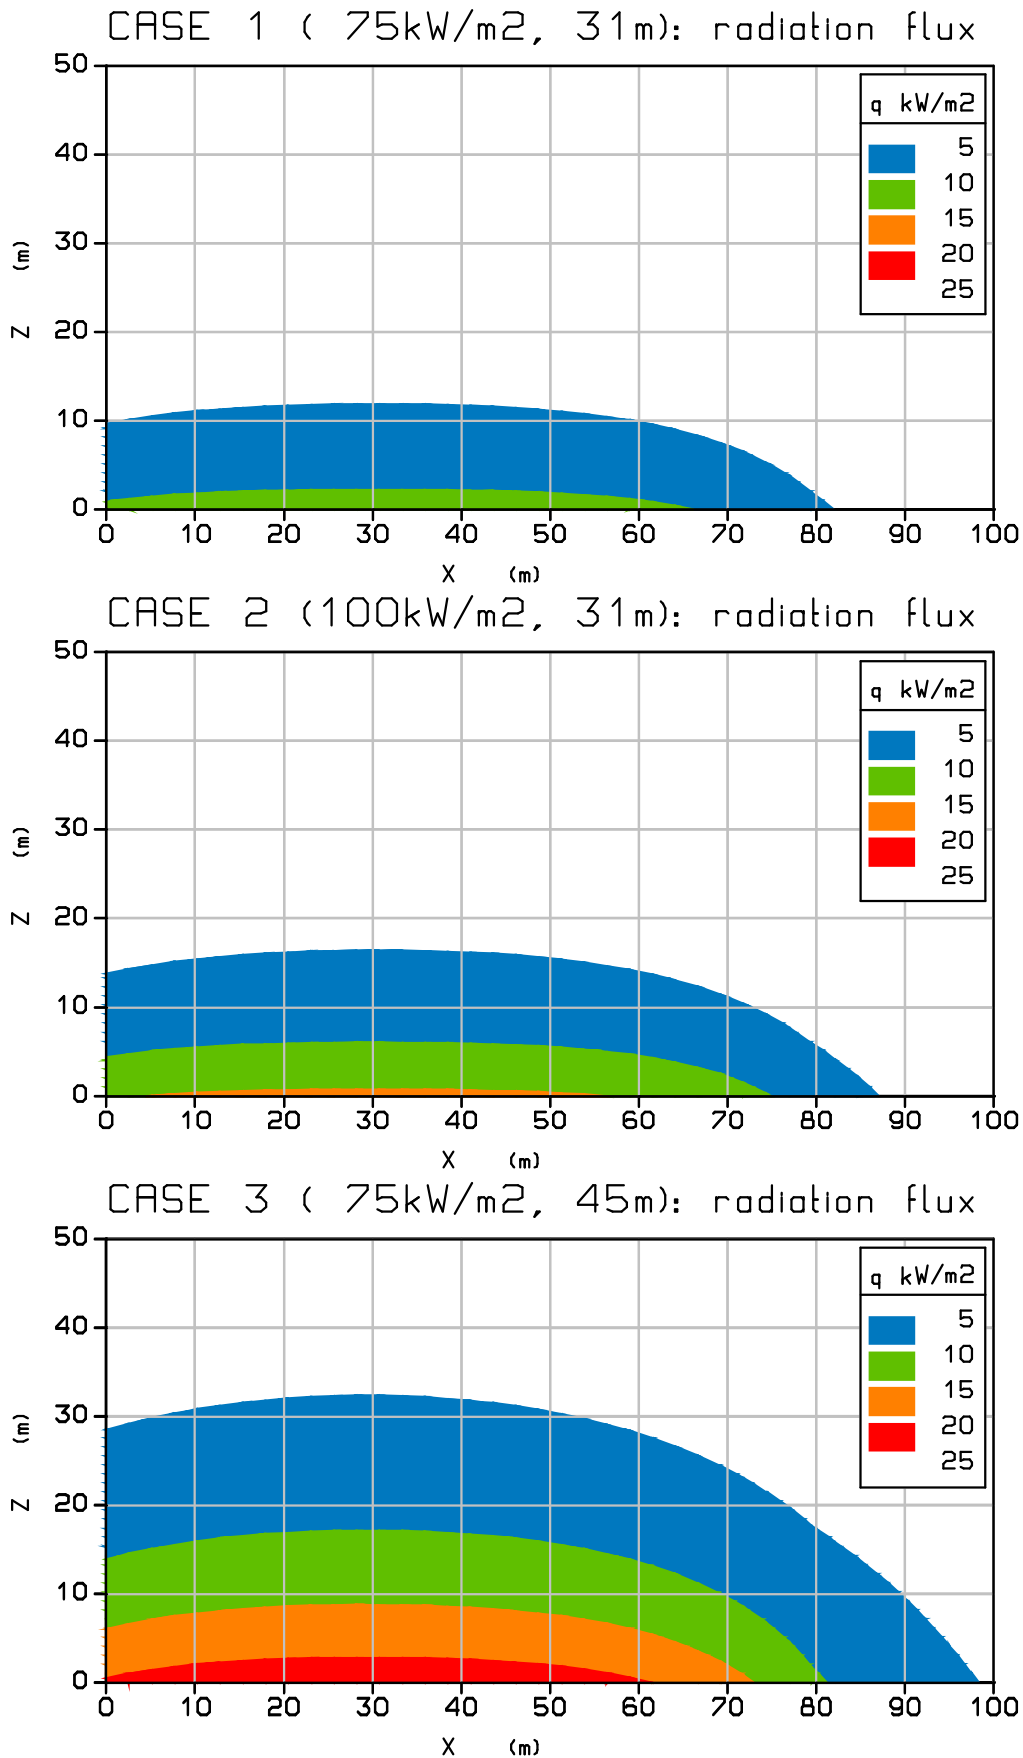
Figure 13 Calculated radiant heat flux on the roof of the virtual Asia building

Figure 13 shows the estimated heat flux on the surface of the roof. Figure 14 shows the estimated temperature on the roof. The temperature is calculated based on an estimated air temperature³ of 30°C and an average wind speed of 5 m/s.

Based on the photos and calculations Efectis estimated the impact of the fire on the roof of the Asia Express Food building. In both case 2 and 3, as presented in chapter 4, the heat flux exceeds 15 kW/m^2 . Surface temperatures rise to 300°C and higher. The shape of the heated area on the virtual roof fits the shape of the damage on the real roof. The width of the calculated heated area is larger than the width of the real damaged area. This can be explained by the uncertainty about and variation in the width, the height and the angle of the flames during the fire.

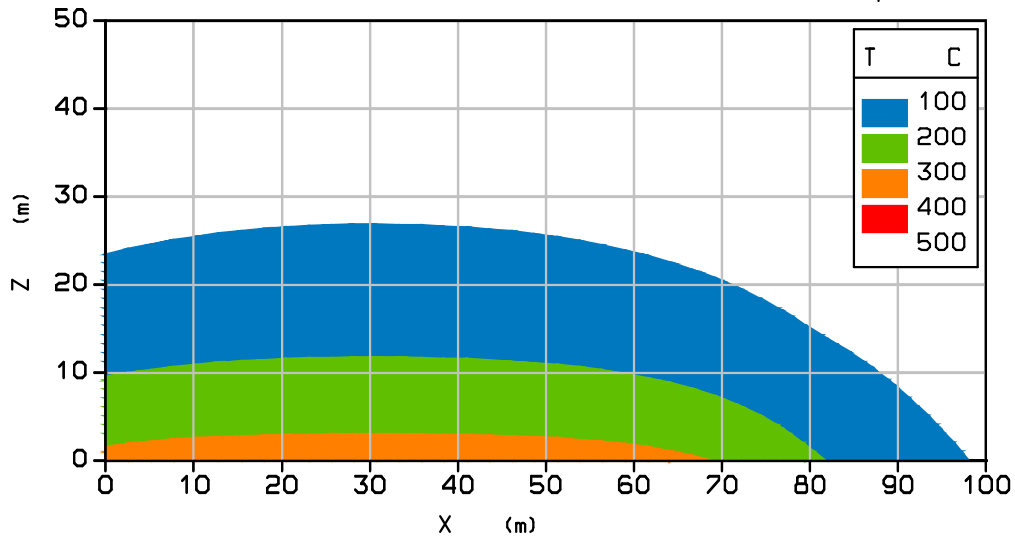
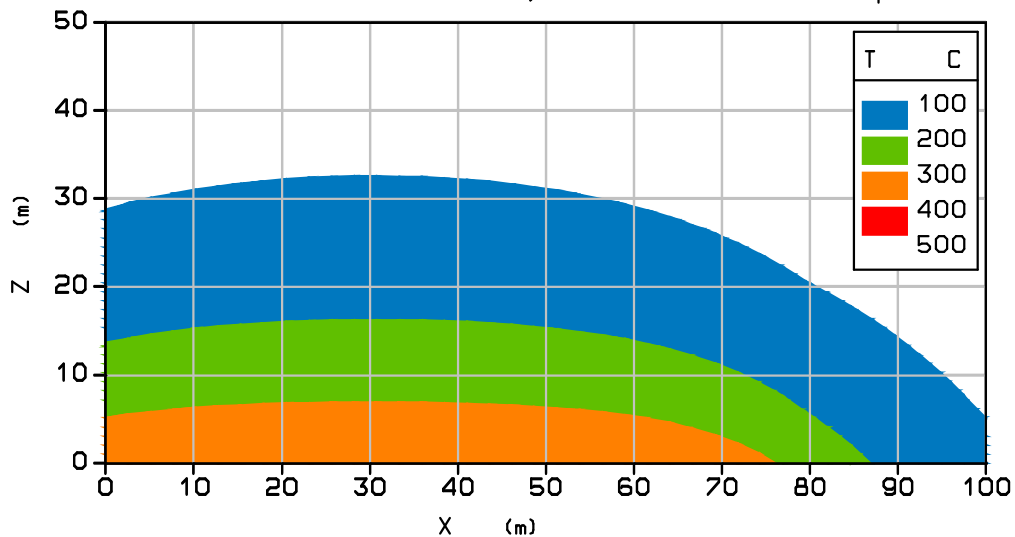
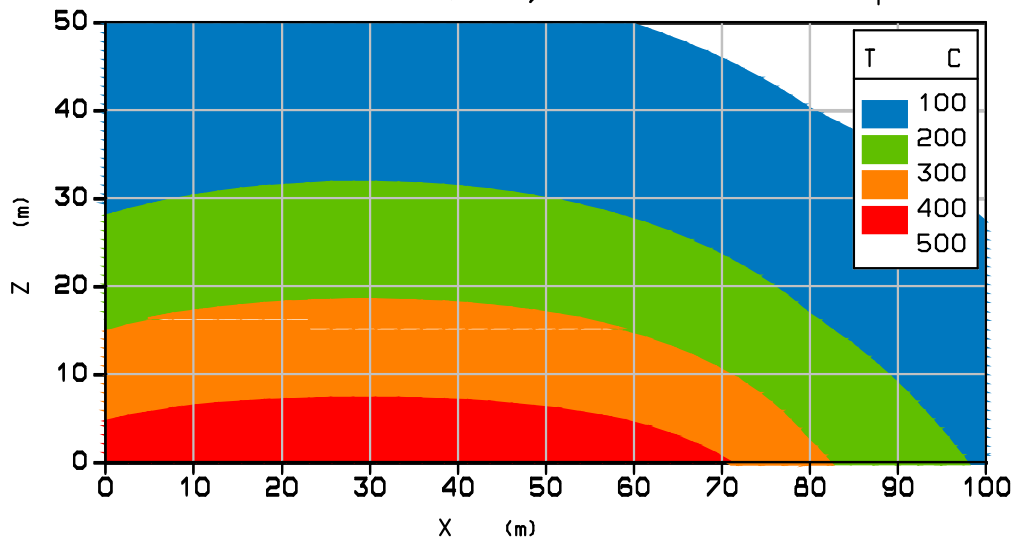
Figure 14 Roof surface temperature on the virtual Asia building

The pictures show that the PVC roof covering was ignited. Therefore it has to be subjected to a heat flux of at least 15 kW/m². The insulation will ignite after the PVC roof covering has burned away. Compared to the calculations in chapter 4 the scenarios 2 and 3 are possible. Based on the surface temperature all 3 scenarios are possible.
